Euro Chieftain System - Technical Data & Warranty Statement

Our Euro Chieftain brackets were developed for reducing wind loading on a lighting column caused by the installation of banners. We certify that our systems conform to the EN40 standard.

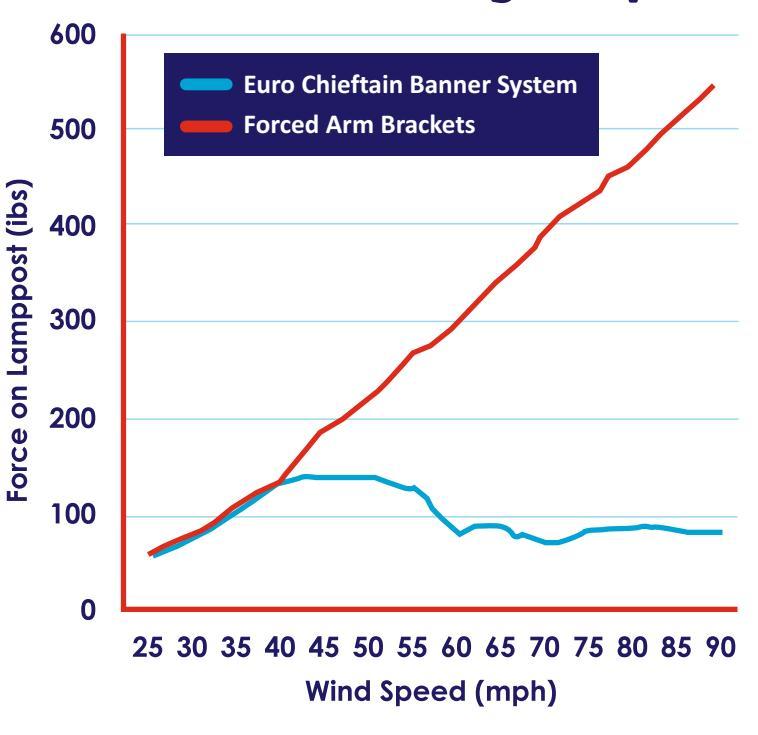
Wind loading Graph

Procedure repeated on fixed arm banner system for comparative measures and the results shown on graph to the right.

Loading Results:

Euro Chieftain max loading of 63.42kgs @ 50mph (Based on 2 banners installed on one column total 3.08sq.m).

Results: Linearity of the load cell is 0.57kgs max up to 63.42kgs.

Load reduction starts occurring between 40 and 50mph. Wind force overcame the spring force of the system at the above speed, the Euro Chieftain bracket changed direction of the banner according to the direction of wind. The banner rotated to such a degree that at 70mph some of which started in a perpendicular position to the wind direction, billowed and turned, such that at over 70mph the middle of the banners were actually partially hidden behind the pole. This rotation was very significant in reducing the exposed area to the wind velocity and limiting the force to the pole.

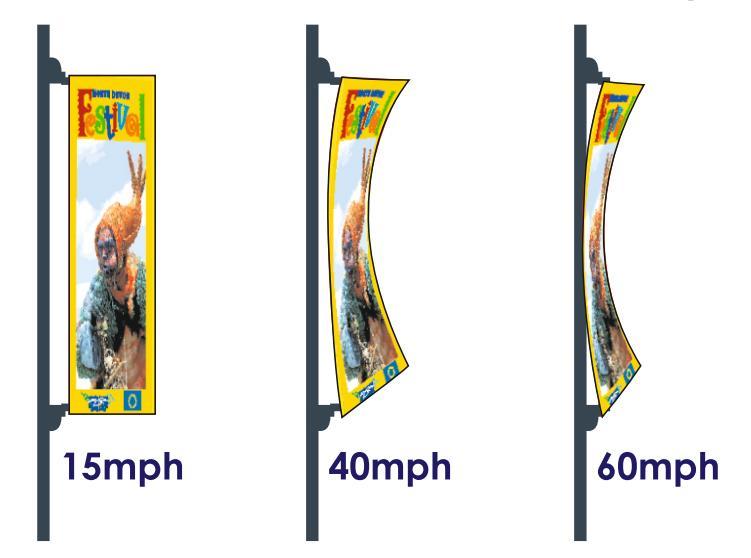
Bracket Reaction in different wind speeds

Wind Tunnel Test Data
